APPENDIX II
SITE PHOTOGRAPHS

*Area 2-J & D Towing;
Sites 5 & 6*

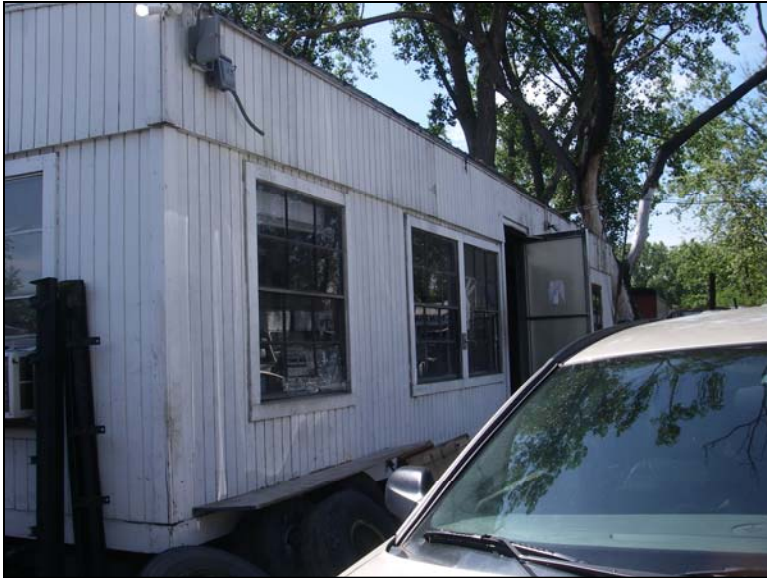
PHOTO 1

Mobile trailer used as an office on Site 5.

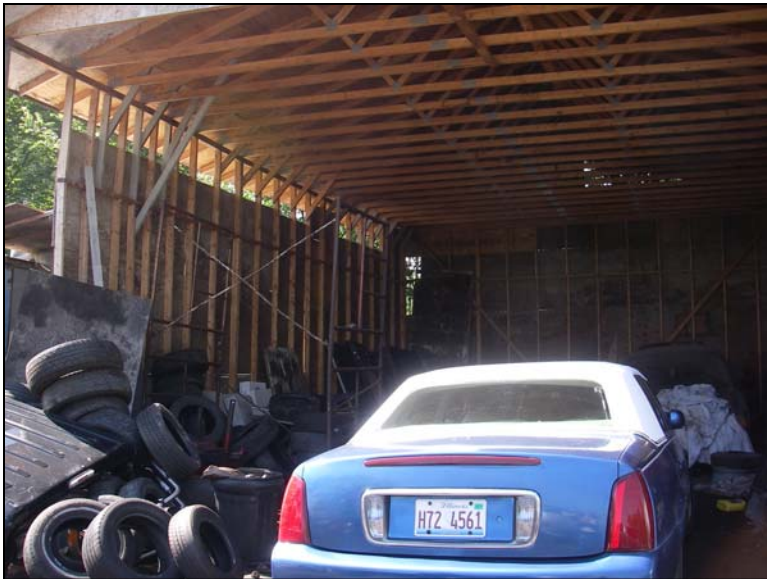
PHOTO 2

Three-sided garage where automotive work is performed on Site 5.

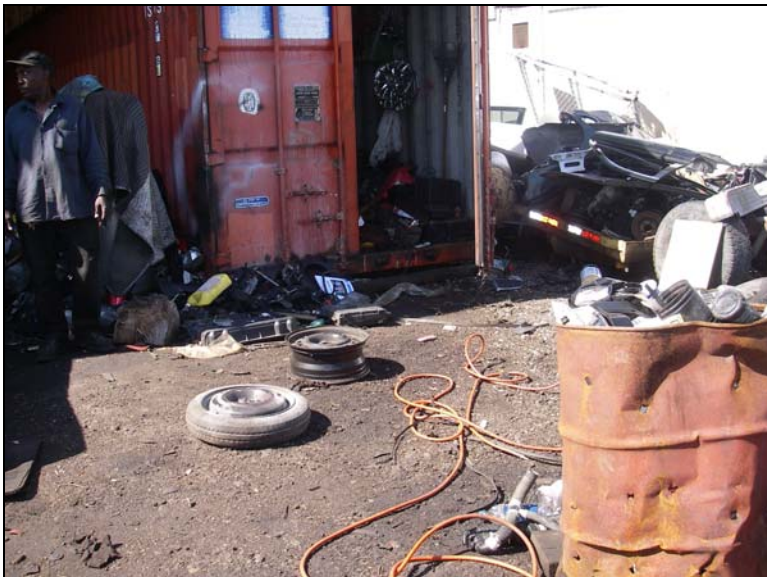
PHOTO 3

Area where automotive work is performed adjacent to the three-sided garage.

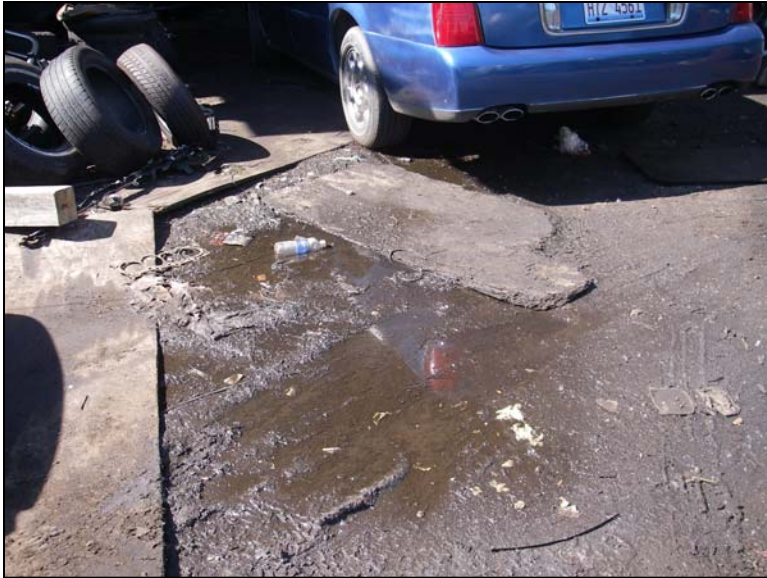
PHOTO 4

Pooled automotive waste fluids on exposed soils in area where automotive work is performed.

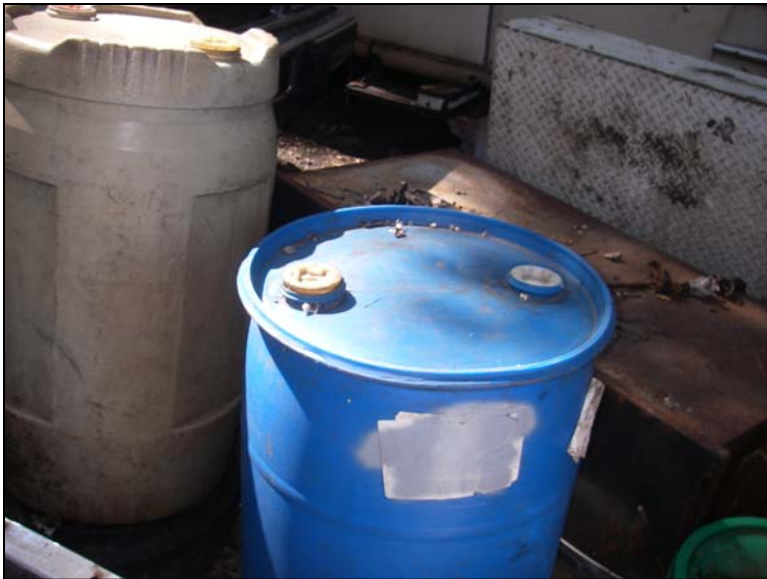
PHOTO 5

Drums containing improperly stored automotive waste fluids on Site 5.

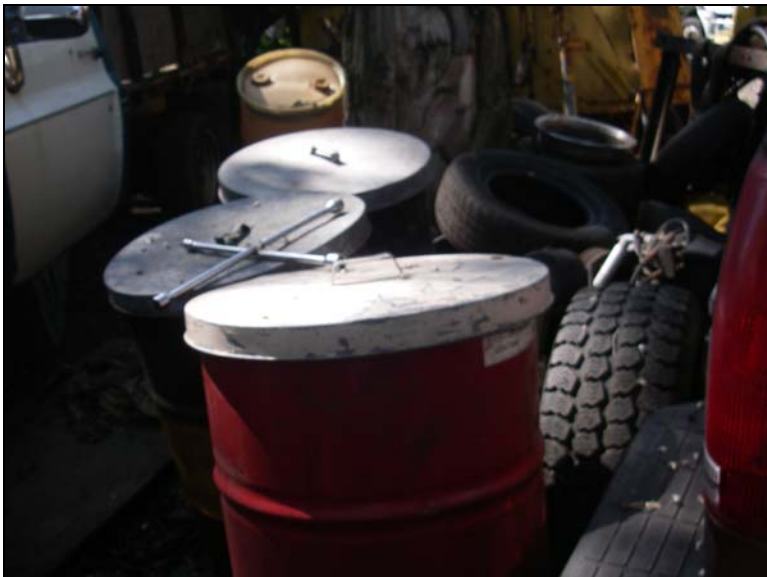
PHOTO 6

Drums containing improperly stored automotive waste fluids on Site 5.

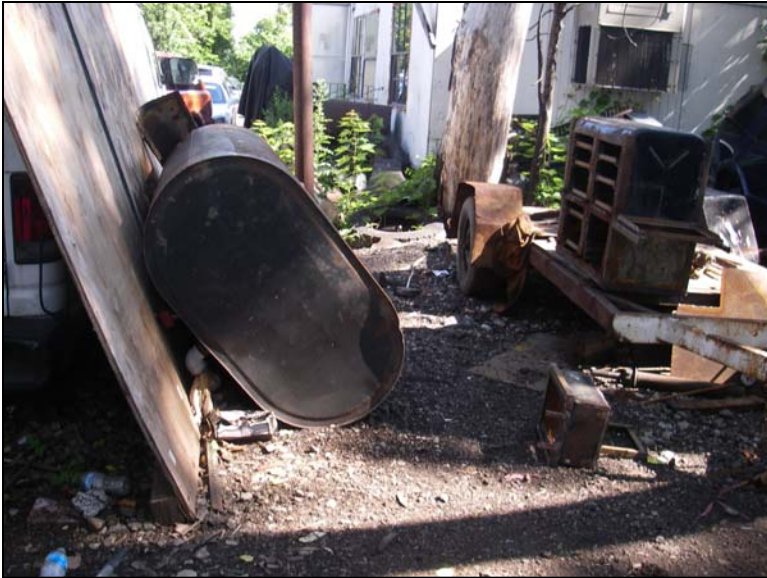
PHOTO 7

AST and associated staining to exposed soils on Site 5.

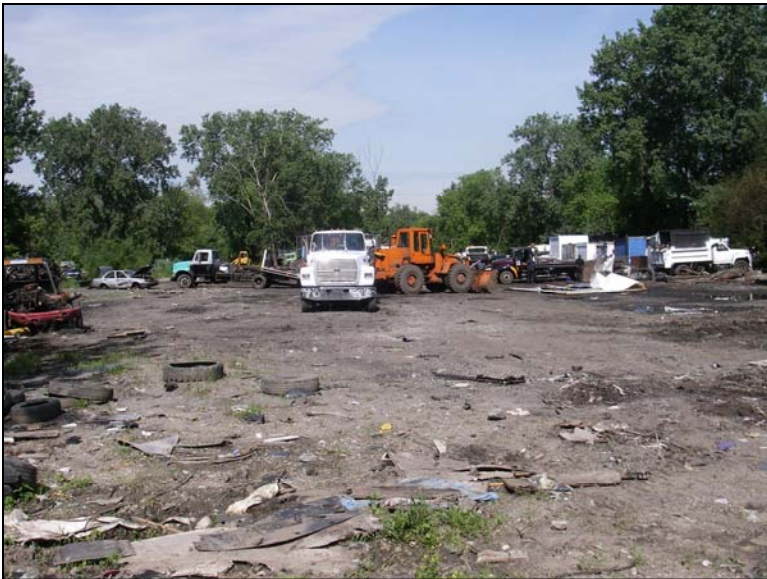
PHOTO 8

East side of junkyard looking west on Site 5.

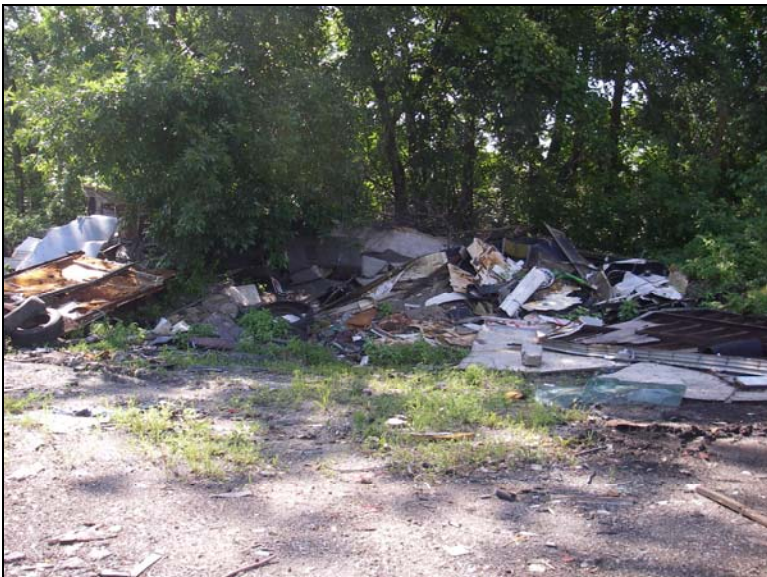
PHOTO 9

Building debris near east property boundary on Site 5.

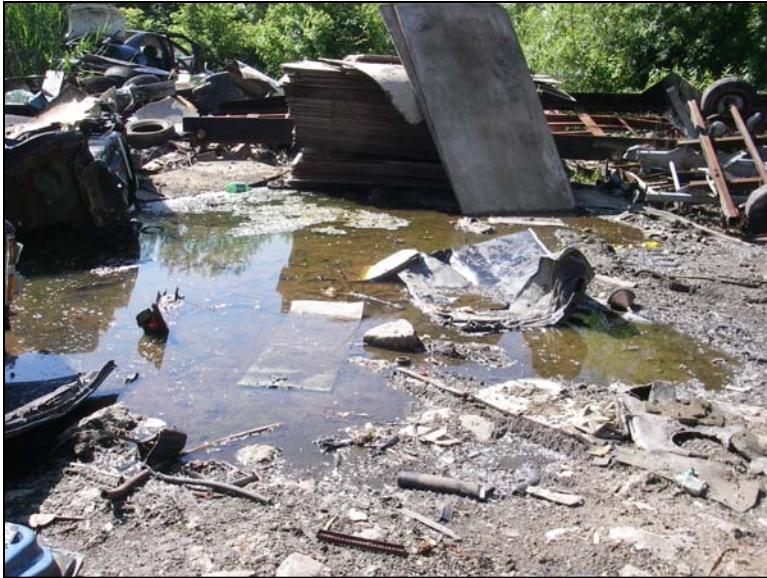
PHOTO 10

Typical junk storage, staining and impacted ponded water observed on exposed soils in junkyard on Site 5.

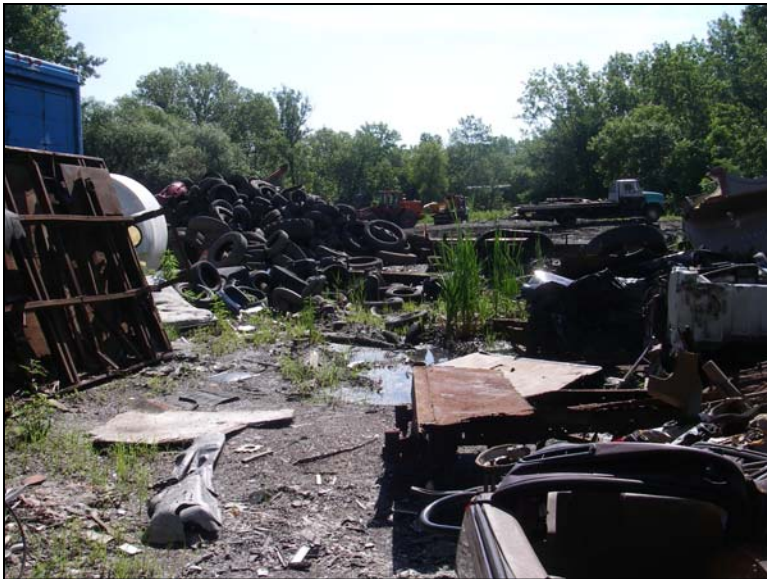
PHOTO 11

Typical automotive junk storage practices, staining observed on exposed soils and impacted ponded water in junkyard on Site 5.

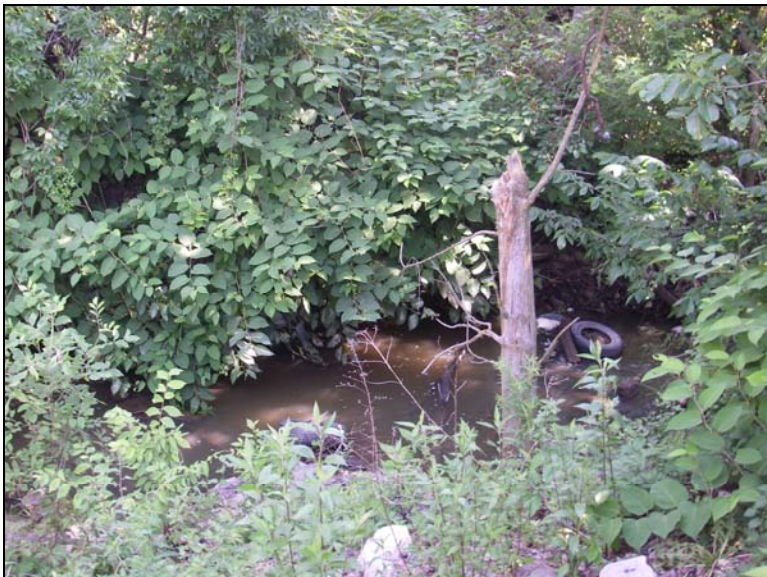
PHOTO 12

Midlothian Creek along the north side of Site 5.

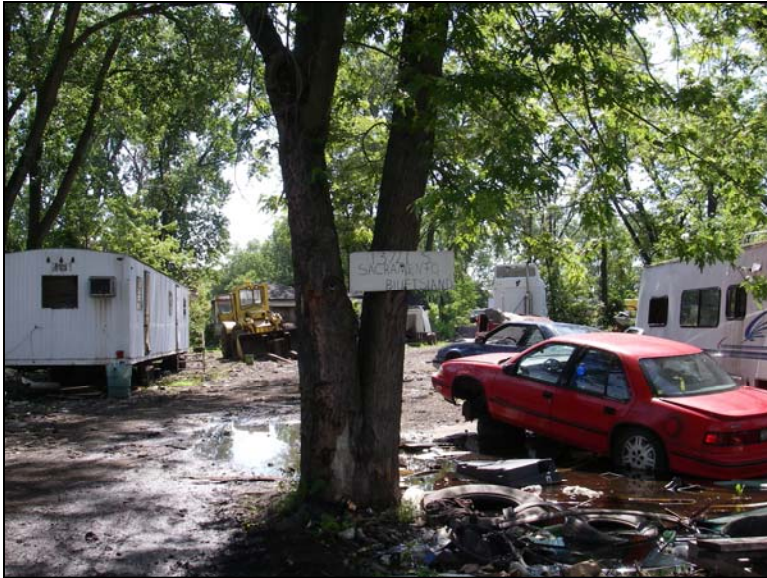
PHOTO 13

West side of Site 6 looking east.

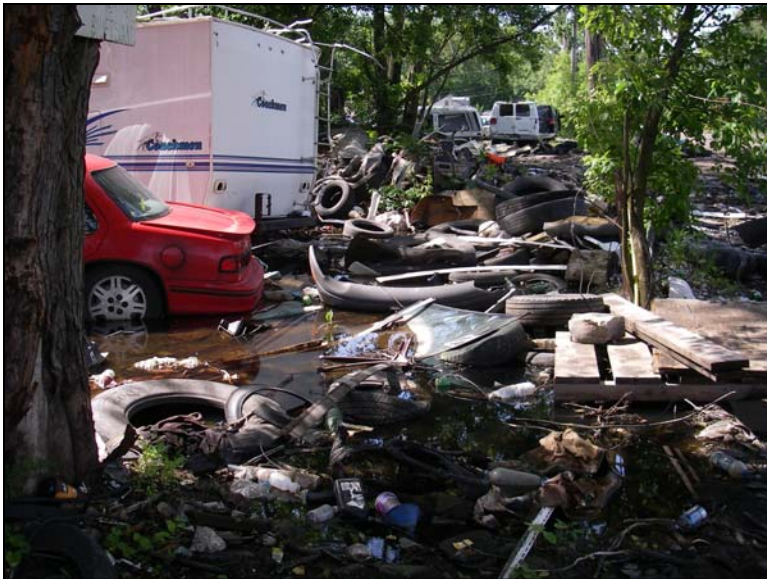
PHOTO 14

Junk yard on Site 6.

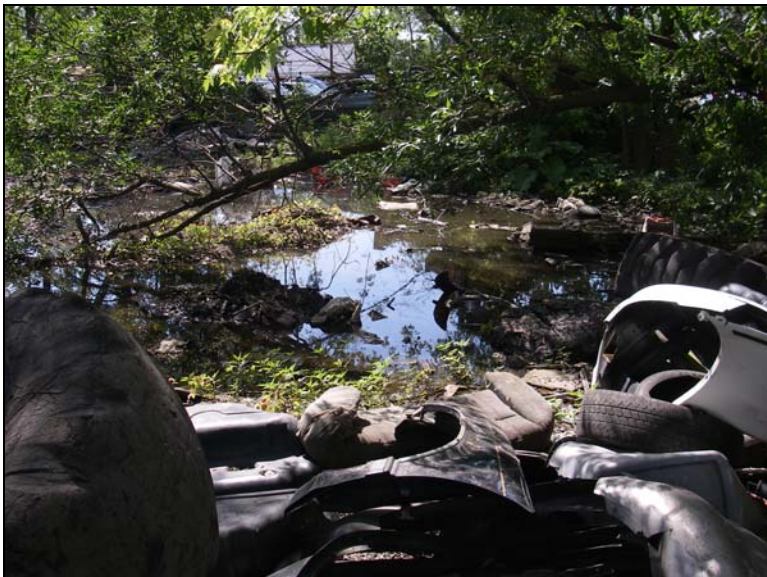
PHOTO 15

Ponded water on Site 6.

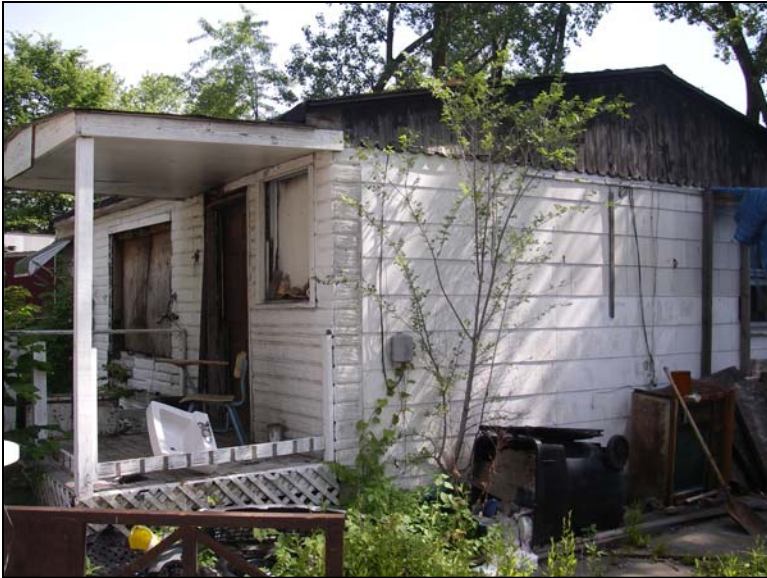
PHOTO 16

Abandoned residence on Site 6.

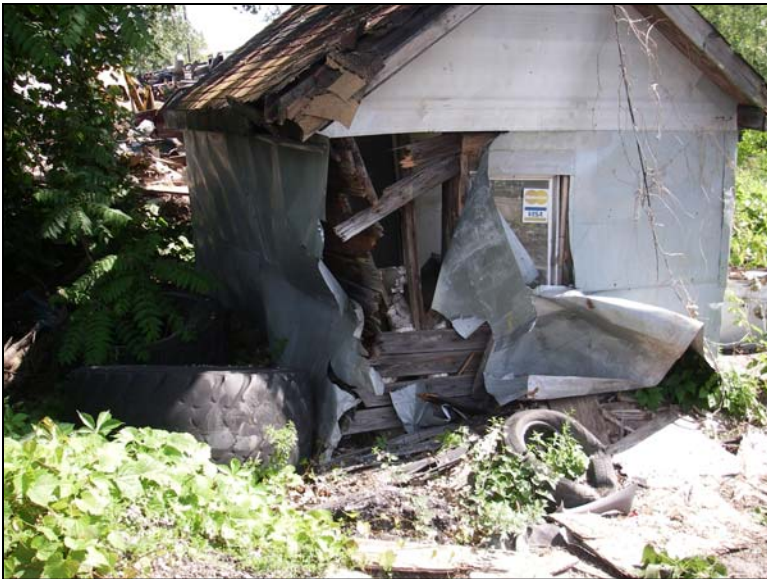
PHOTO 17

Abandoned shed on Site 6.

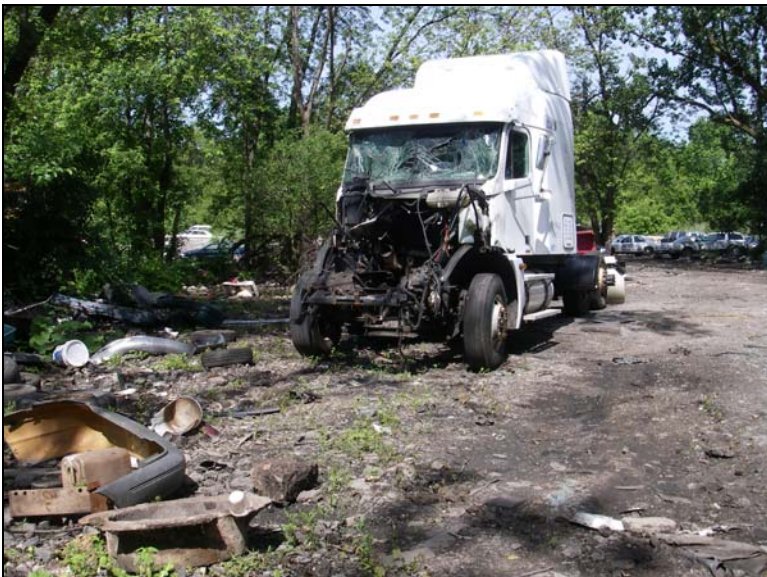
PHOTO 18

Debris on east side of Site 6.
