APPENDIX D
PHOTOGRAPHIC DOCUMENTATION

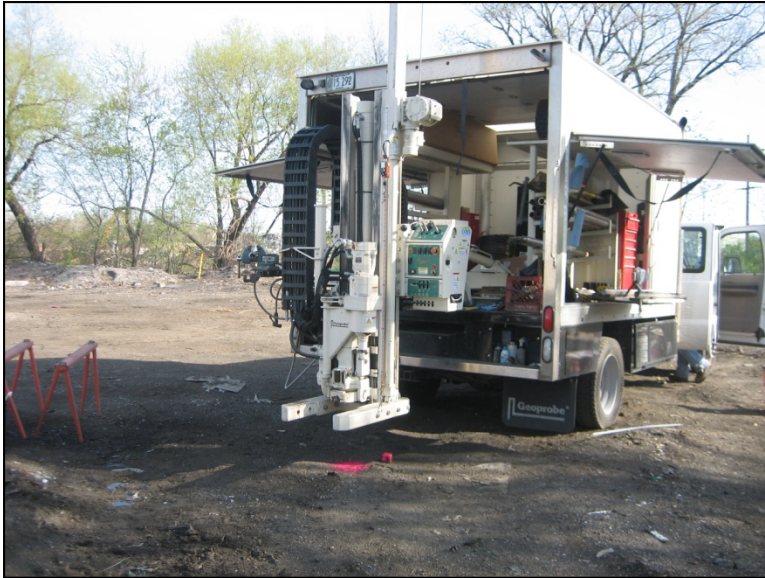
PHOTO 1

View of soil boring location JD-GP-20 and OSE's Geoprobe 6600, facing northeast.

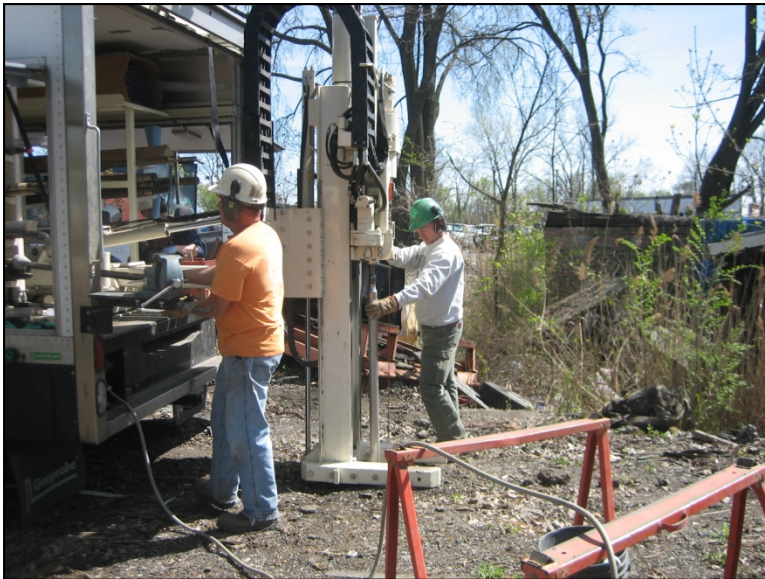
PHOTO 2

OSE drilling soil boring JD-GP-27 with Geoprobe 6600, facing southeast.

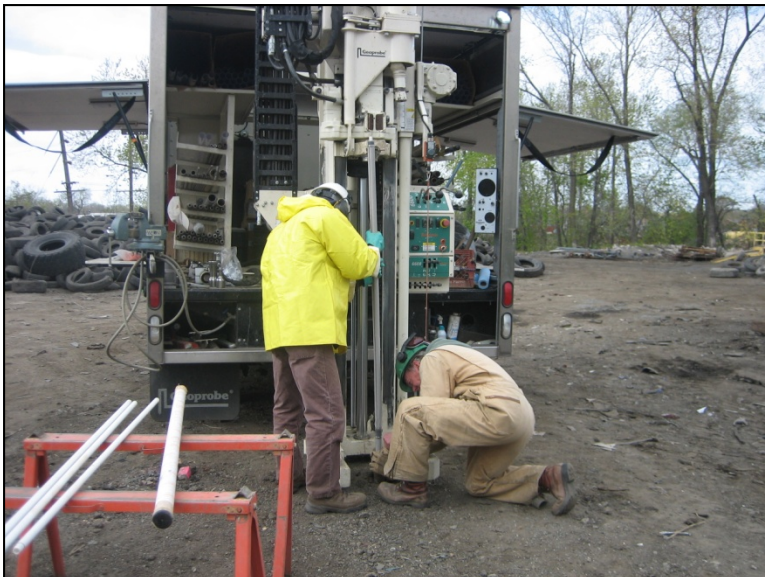
PHOTO 3

OSE installing pre-packed PVC screen at permanent monitoring well JD-GP-40/MW-01, facing northwest.

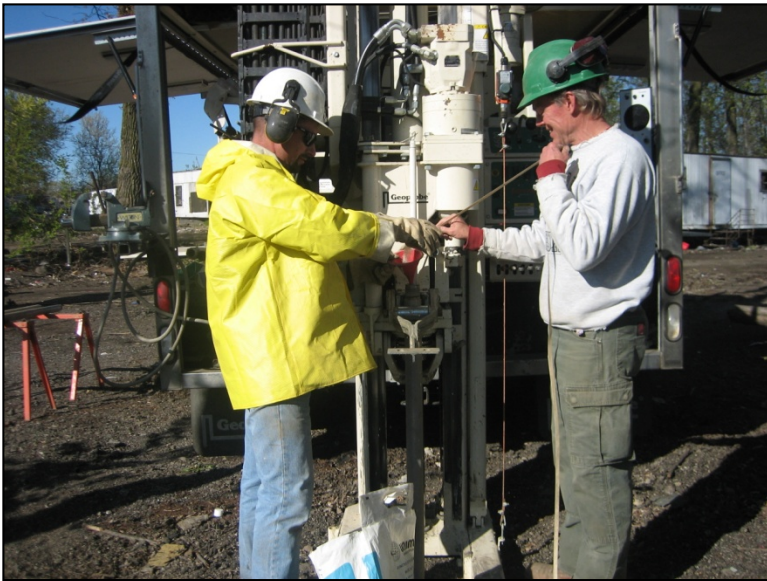
PHOTO 4

OSE installing sand filter pack around pre-packed permanent monitoring well JD-GP-05/MW-05, facing southeast.

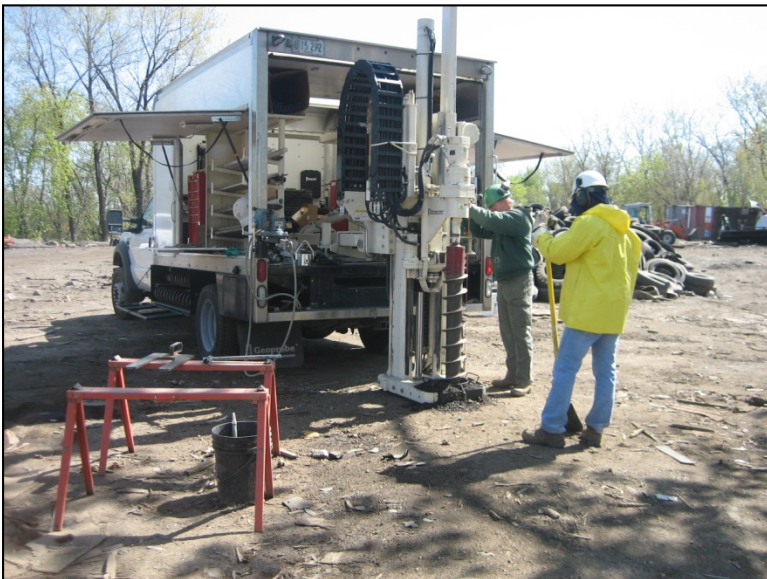
PHOTO 5

OSE drilling two-inch permanent monitoring well MW-02, facing northeast.

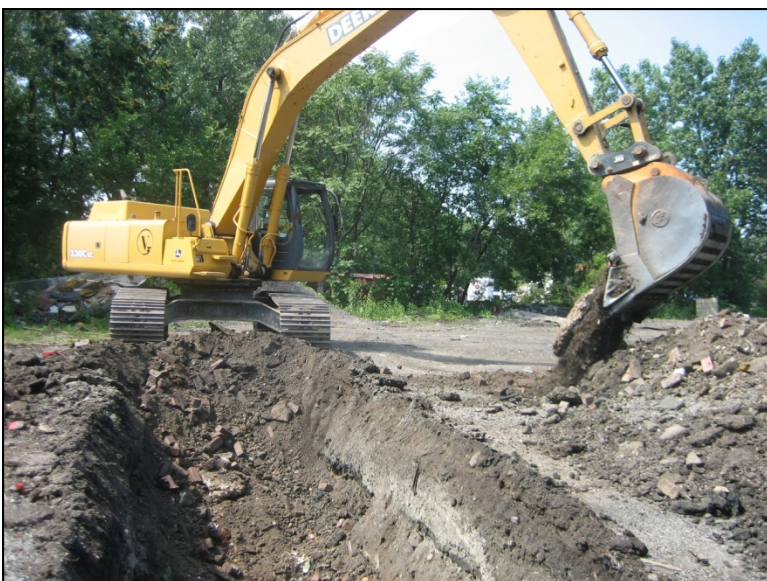
PHOTO 6

V3's backhoe excavating test pit TP-04 and stock piling soils adjacent to test pit, facing south.

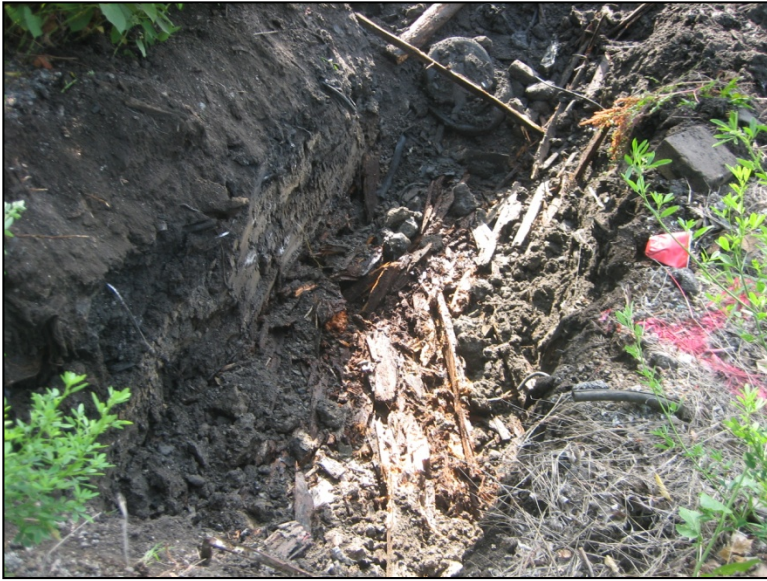
PHOTO 7

Fill and construction debris observed in test pit TP-03, facing southeast.

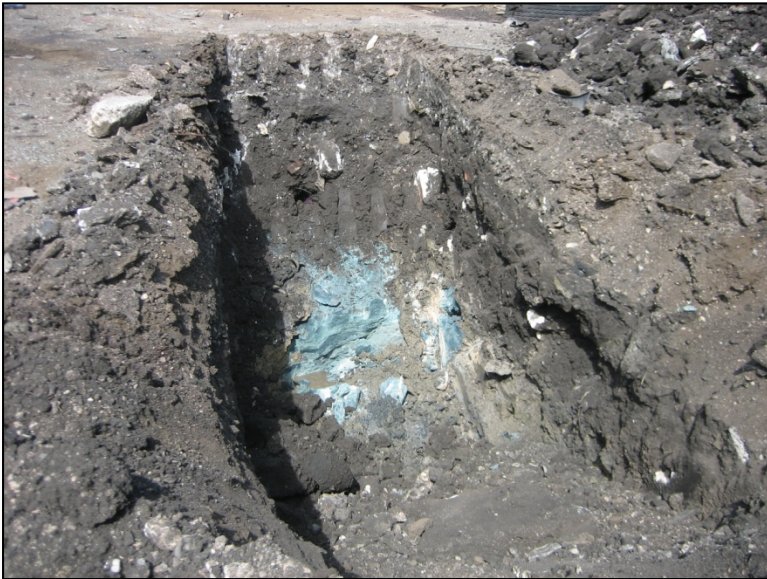
PHOTO 8

Blue poorly graded medium (cemented) sand with sulfur odor observed in test pit TP-07, facing west.

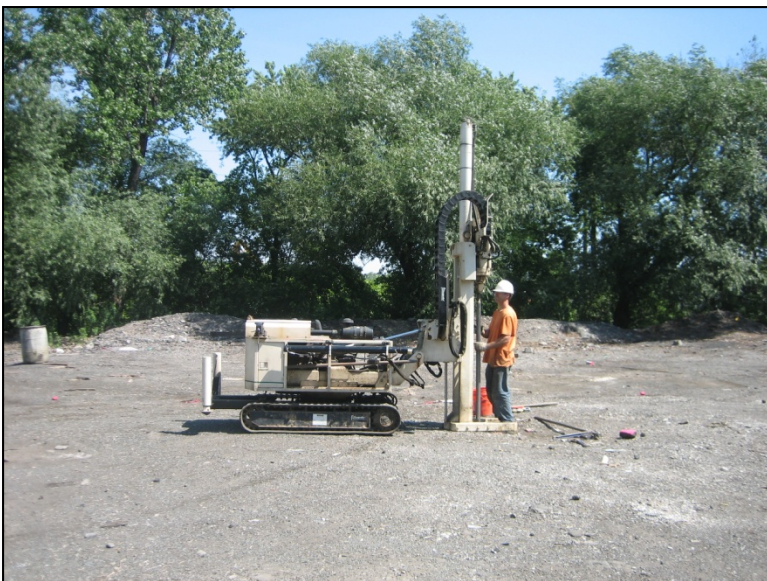
PHOTO 9

Johnson Probing drilling soil boring JD-GP-108 with Geoprobe 6600, facing north.

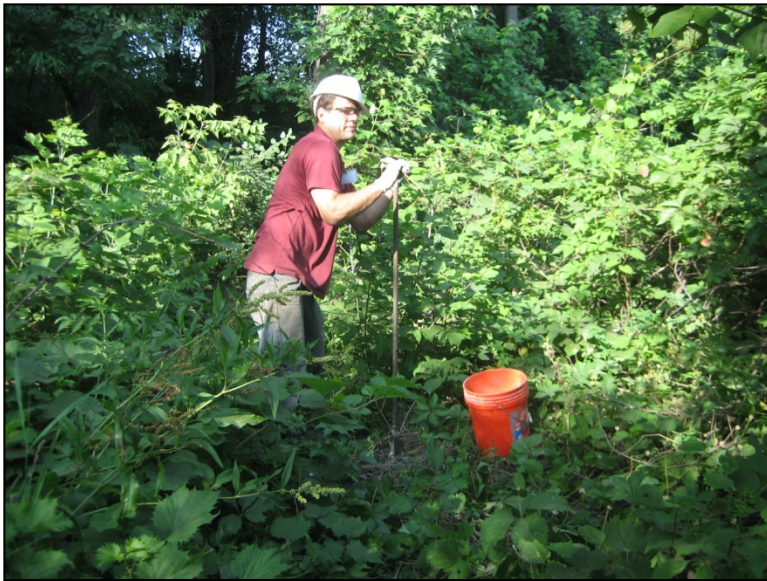
PHOTO 10

Johnson Probing hang
augering soil boring JD-
GP-120 located on the
north side of Midlothian
Creek, facing south.

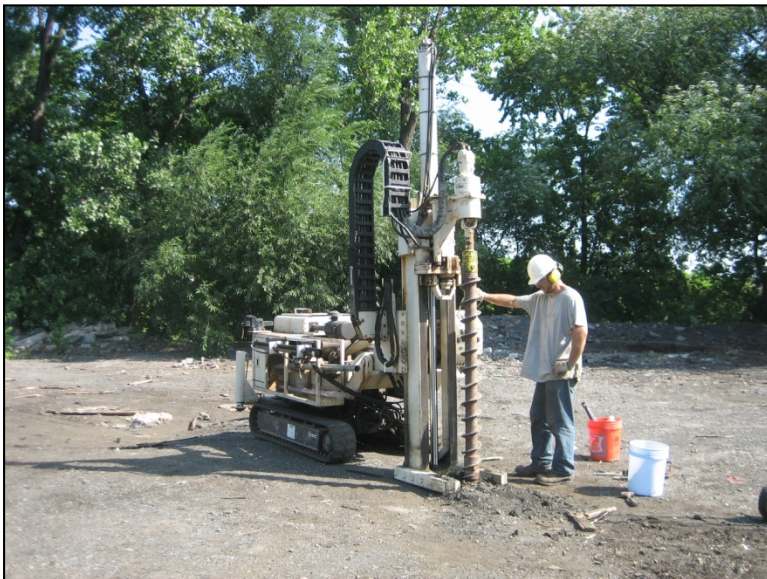
PHOTO 11

Johnson Probing installing
permanent monitoring
well MW-06, facing north.

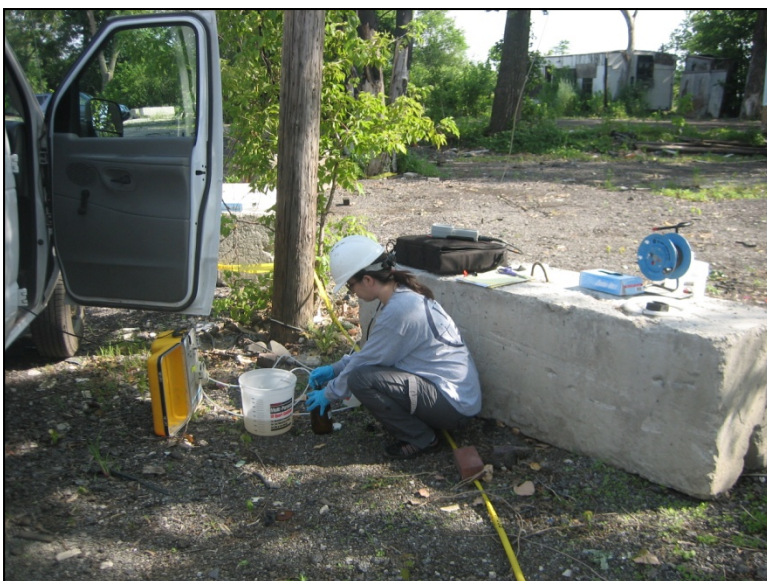
PHOTO 12

V3 low flow sampling
MW-03, facing northeast.
