**PHASE I  
ENVIRONMENTAL SITE  
ASSESSMENT**

**J & D AUTO PARTS - SOUTH COD - AREA 2 - SITES 5 & 6  
S. SACRAMENTO AVENUE  
BLUE ISLAND, IL 60406**

**JULY 2010**

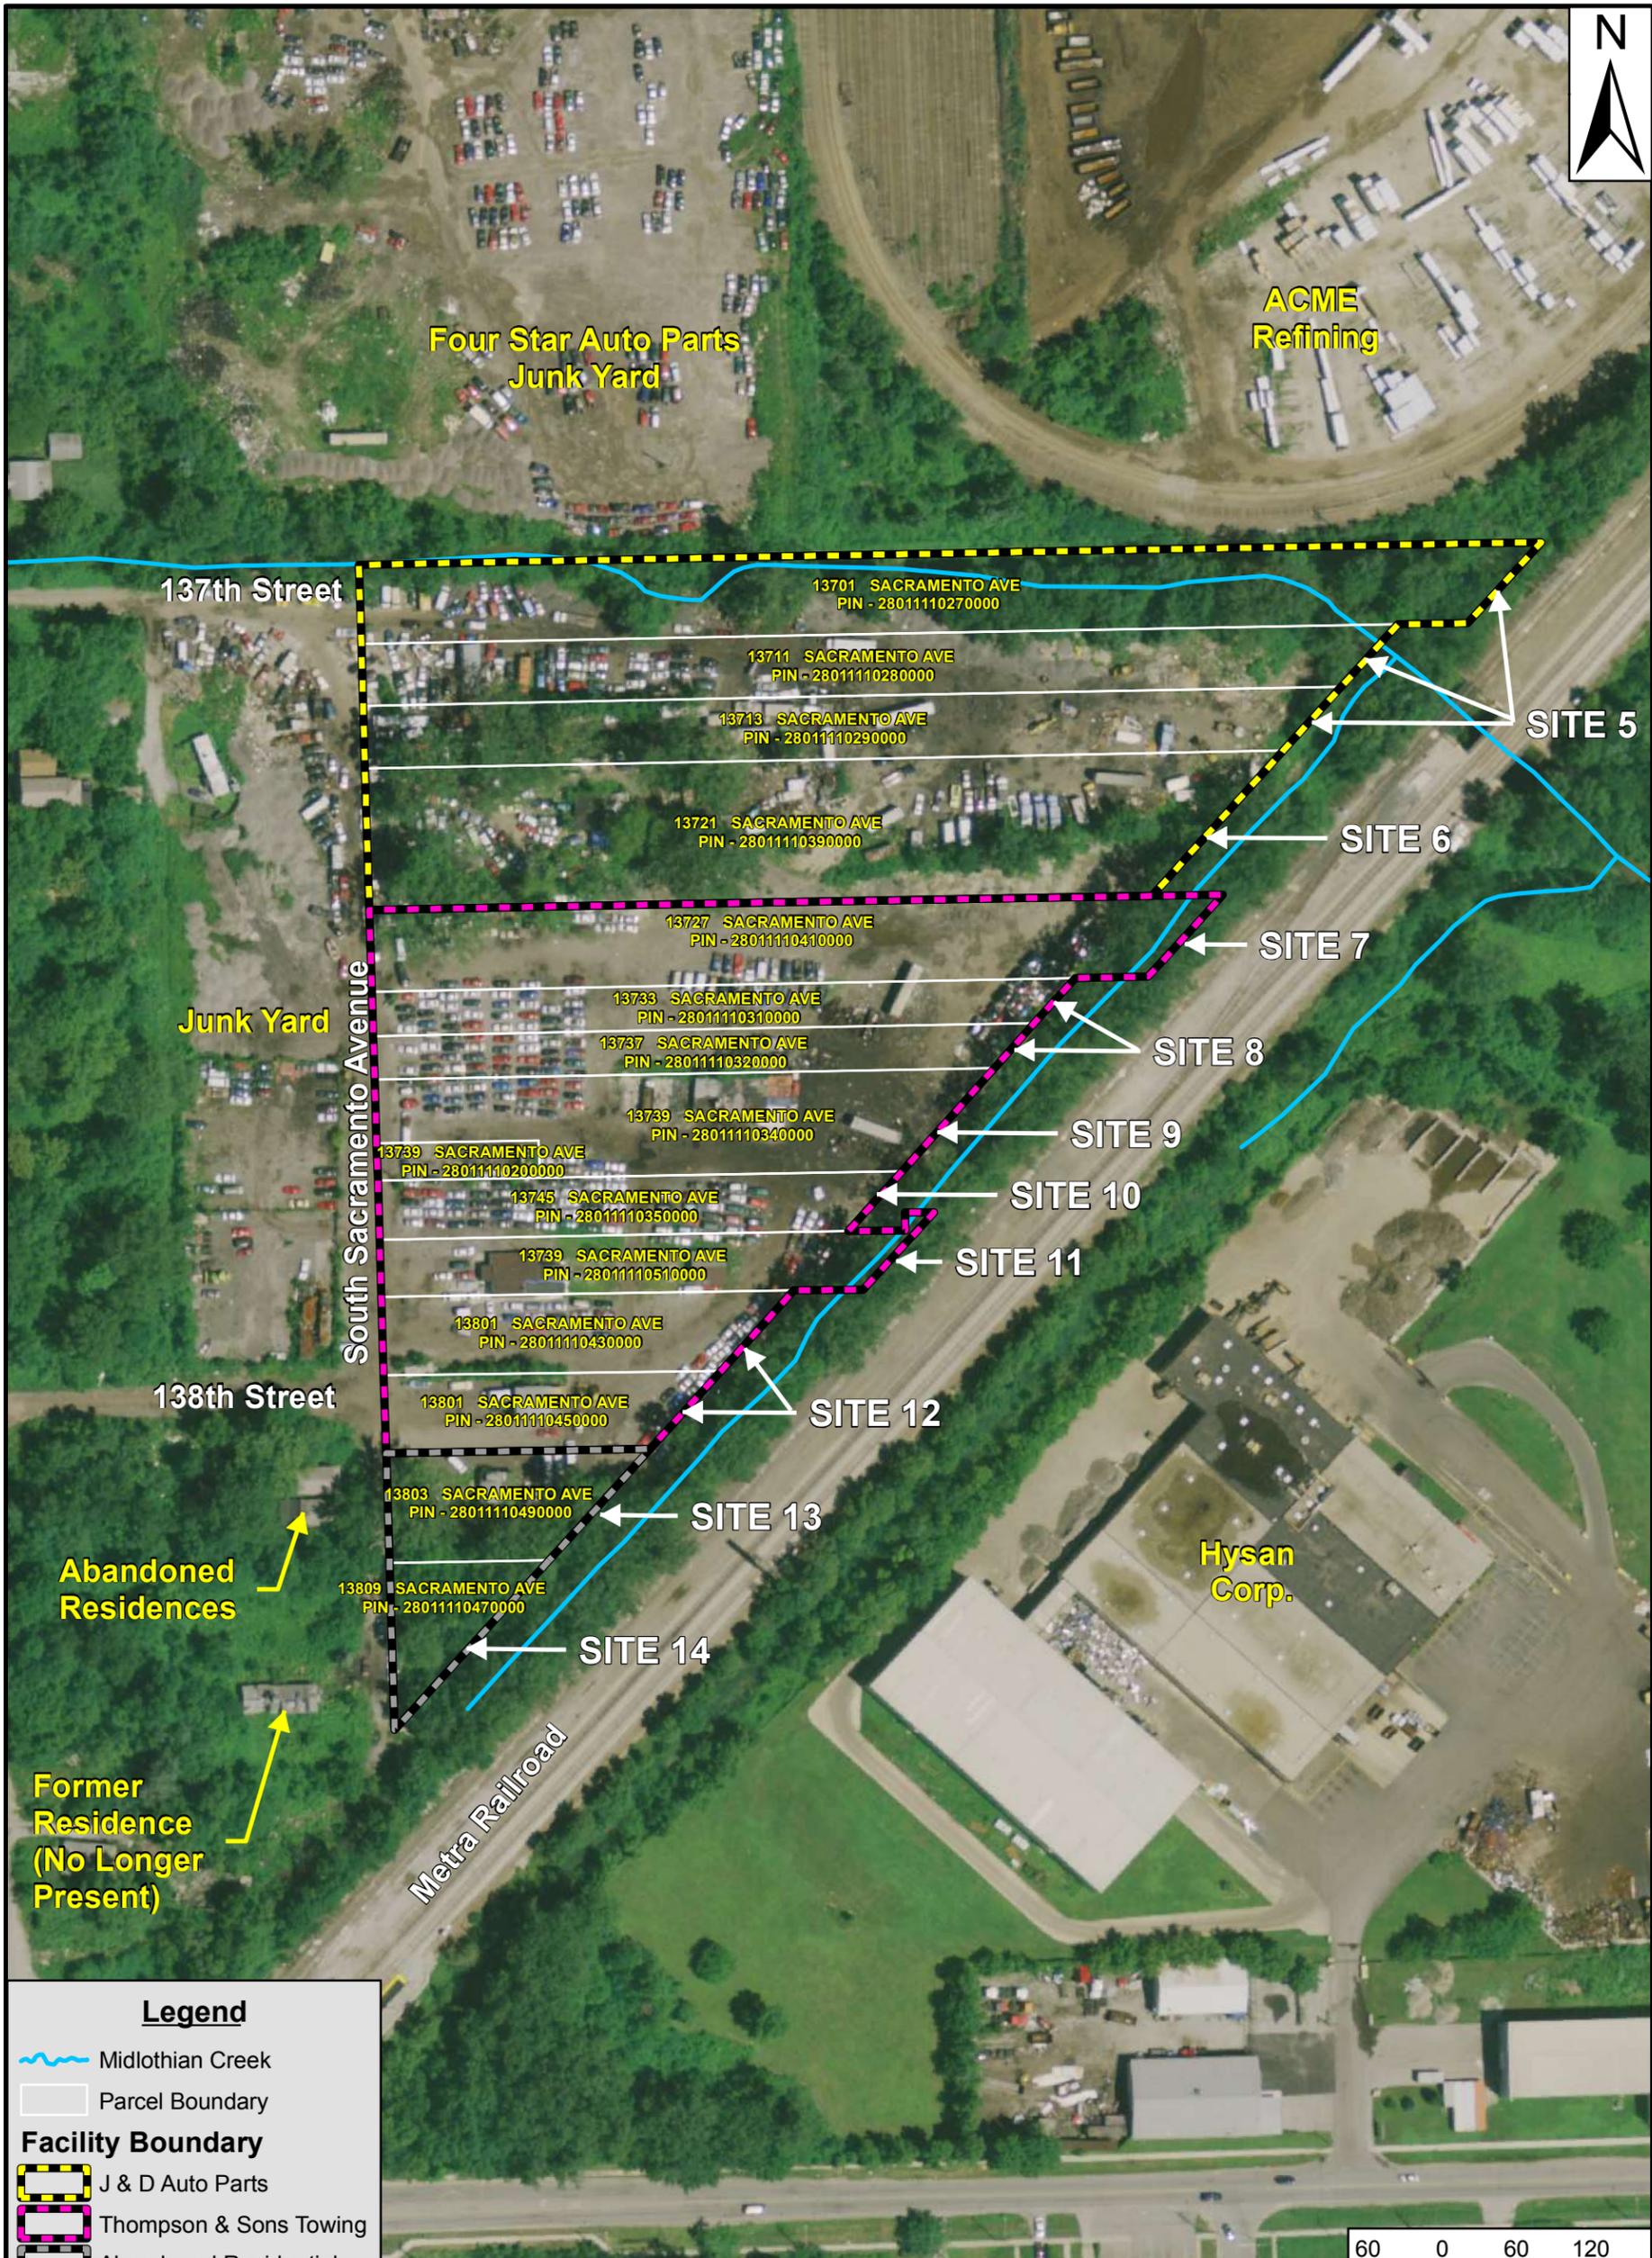
The following subsections comprise information obtained from the site visits, interviews with knowledgeable individuals, and documents and records pertaining to the properties and operations. Additional descriptions regarding site conditions are provided in Section 6.0, Site Reconnaissance and Interviews. A Site Location Map is provided as Figure 1, a Site Features Map as Figure 2 and a Site Details Map for Sites 5 and 6 (Figure 3a).
