A Red Light Running (RLR) Photo Enforcement System was installed at the intersection of 127th Street at Gregory Street/Vincennes Road on February 26, 2010 after finding limited success with other attempted measures to promote safer driving and improve compliance with traffic laws. The following statistical analysis was performed through 2015. Calendar year 2016 was not included as the Illinois Department of Transportation (IDOT) has not yet completed collecting all data. The statistical analysis will be updated annually, as collected data becomes available from IDOT.

127th Street at Gregory Street/Vincennes Road
Blue Island, IL

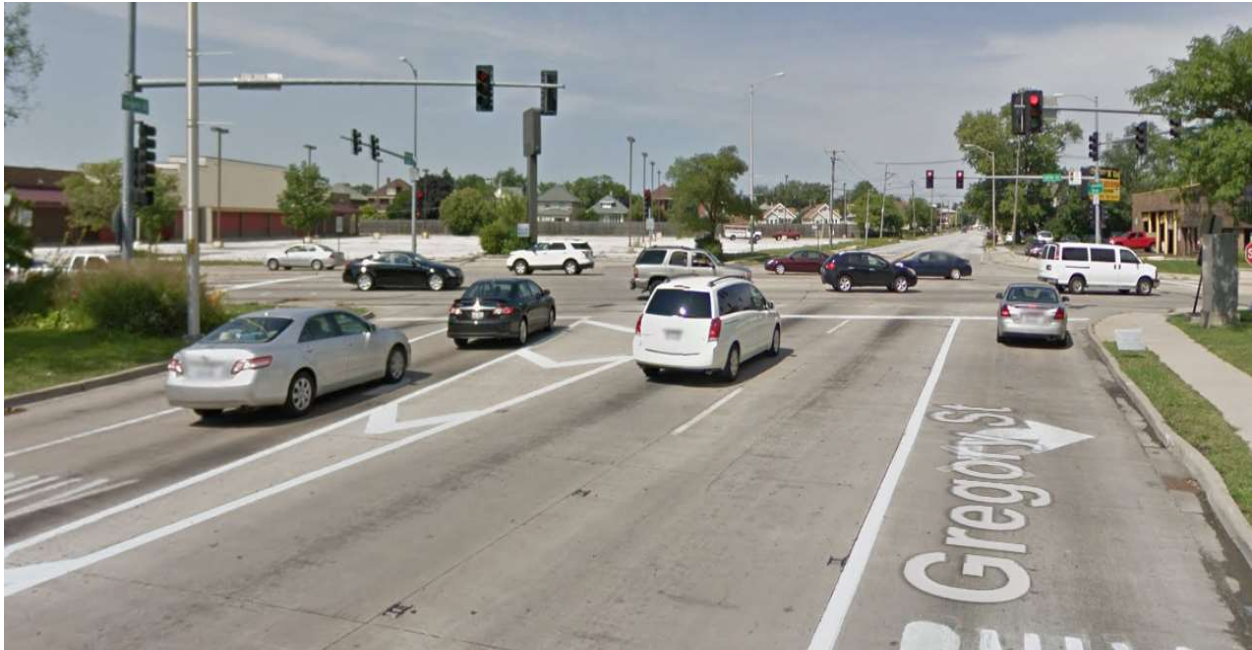
127th Street at Gregory Street/Vincennes Road, Northbound Approach

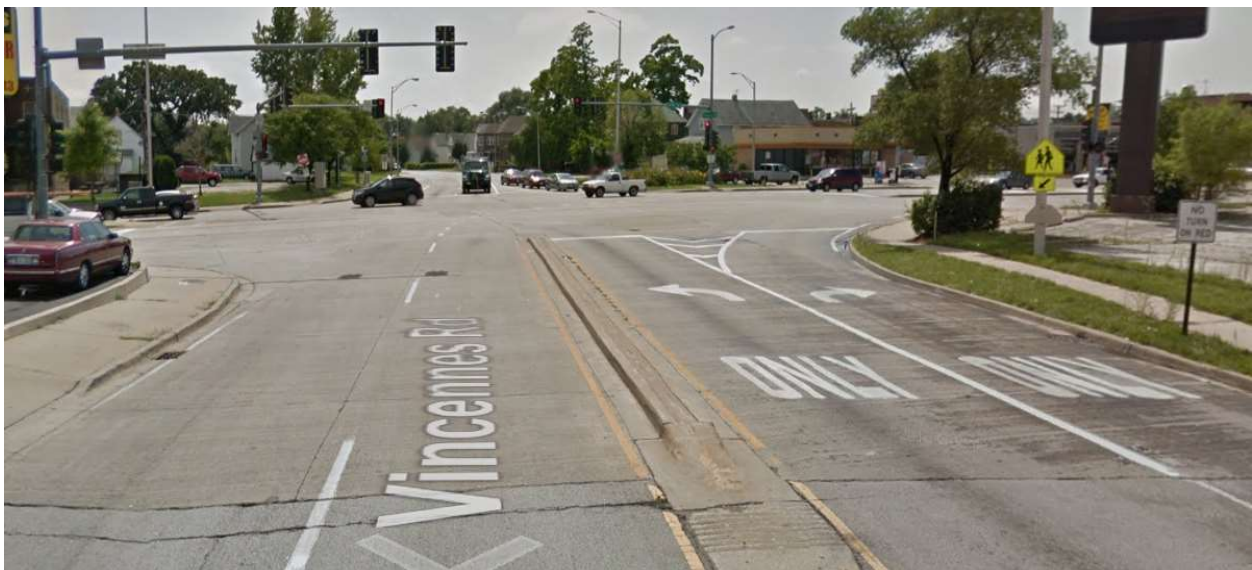
127th Street at Gregory Street/Vincennes Road, Southbound Approach

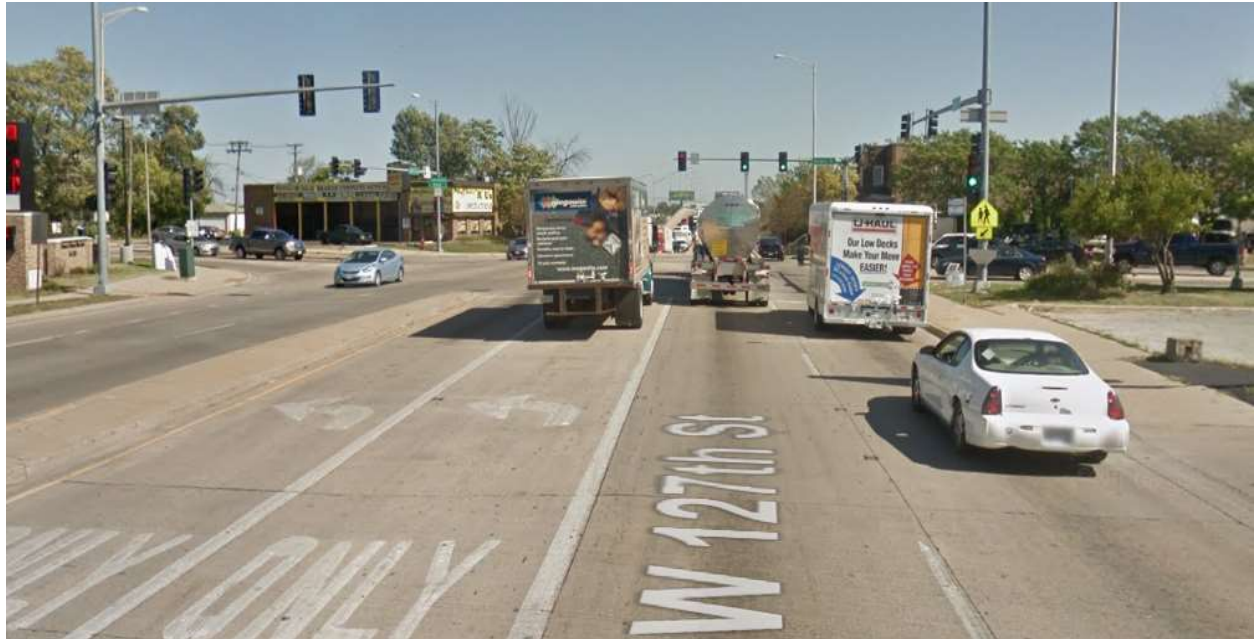
127th Street at Gregory Street/Vincennes Road, Eastbound Approach

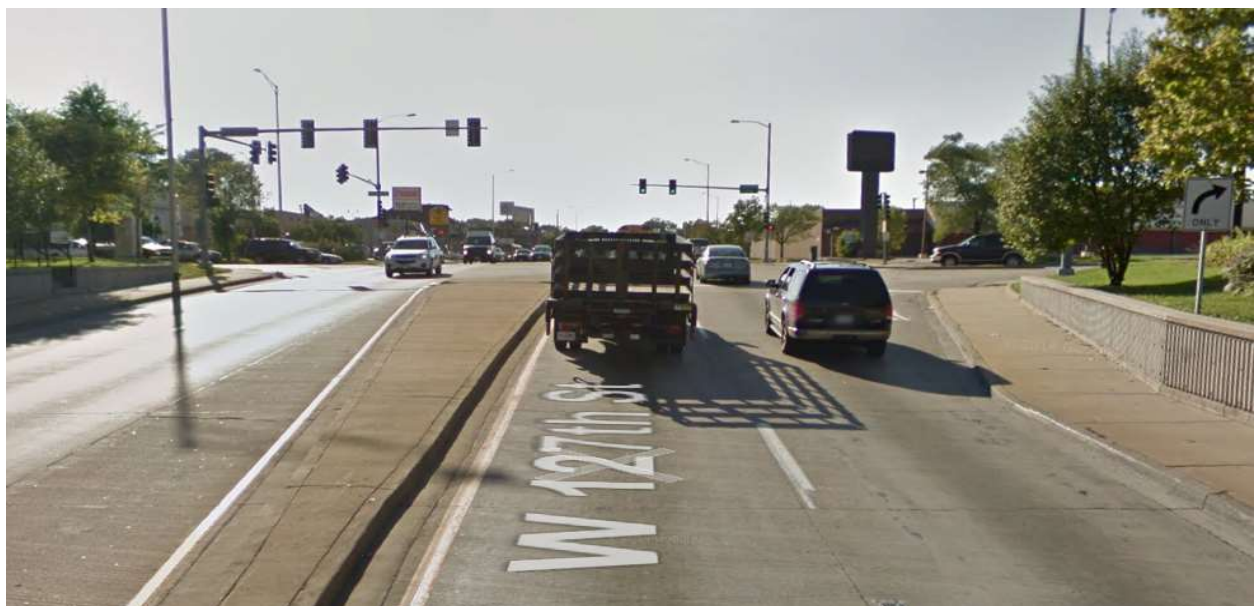
127th Street at Gregory Street/Vincennes Road, Westbound Approach
