A Red Light Running (RLR) Photo Enforcement System was installed at the intersection of 127th Street at Western Avenue on October 10, 2011 after finding limited success with other attempted measures to promote safer driving and improve compliance with traffic laws. The following statistical analysis was performed through 2015. Calendar year 2016 was not included as the Illinois Department of Transportation (IDOT) has not yet completed collecting all data. The statistical analysis will be updated annually, as collected data becomes available from IDOT.

127th Street at Western Avenue
Blue Island, IL

August 9, 2017

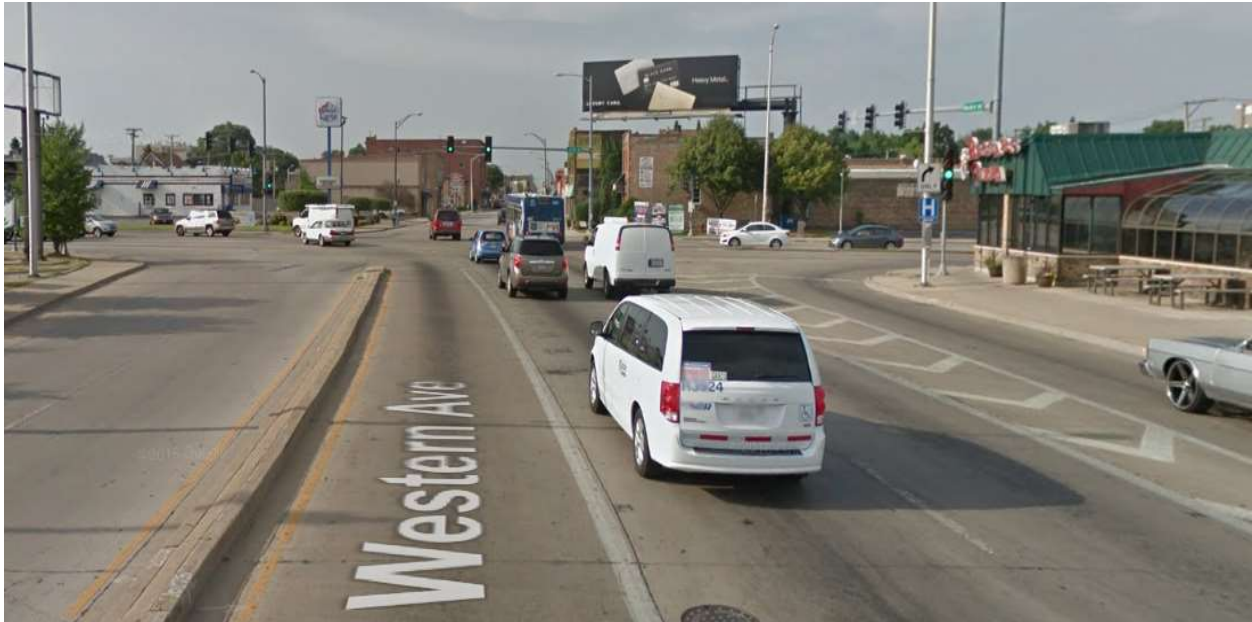
127th Street at Western Avenue, Southbound Approach

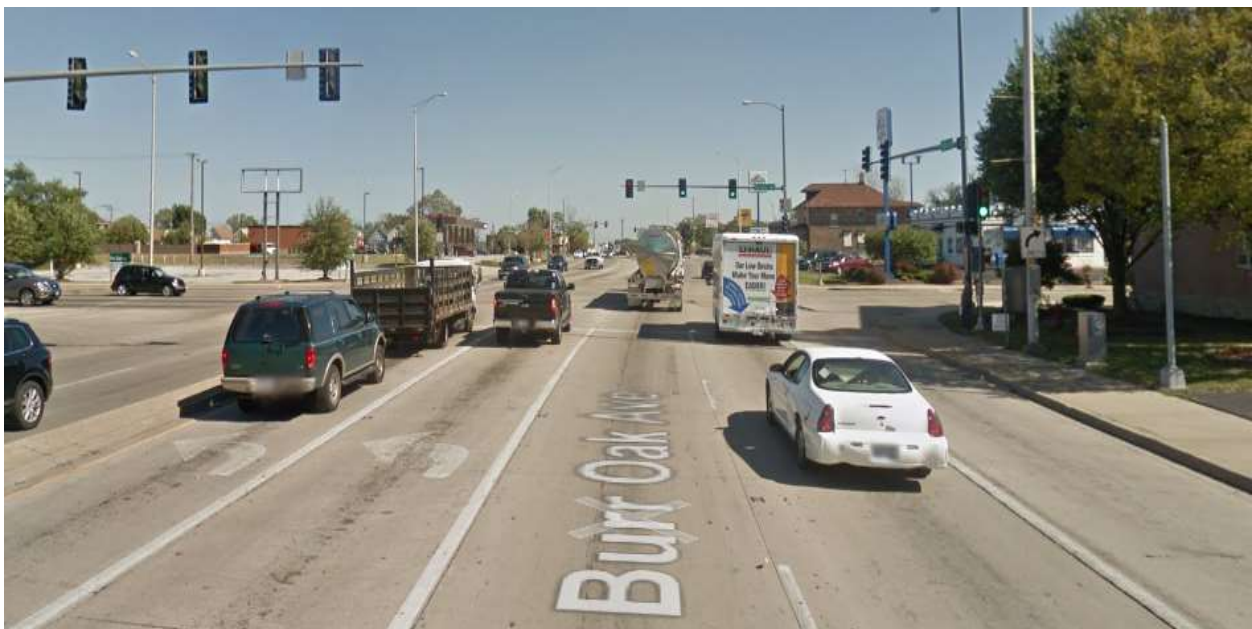
127th Street at Western Avenue, Eastbound Approach

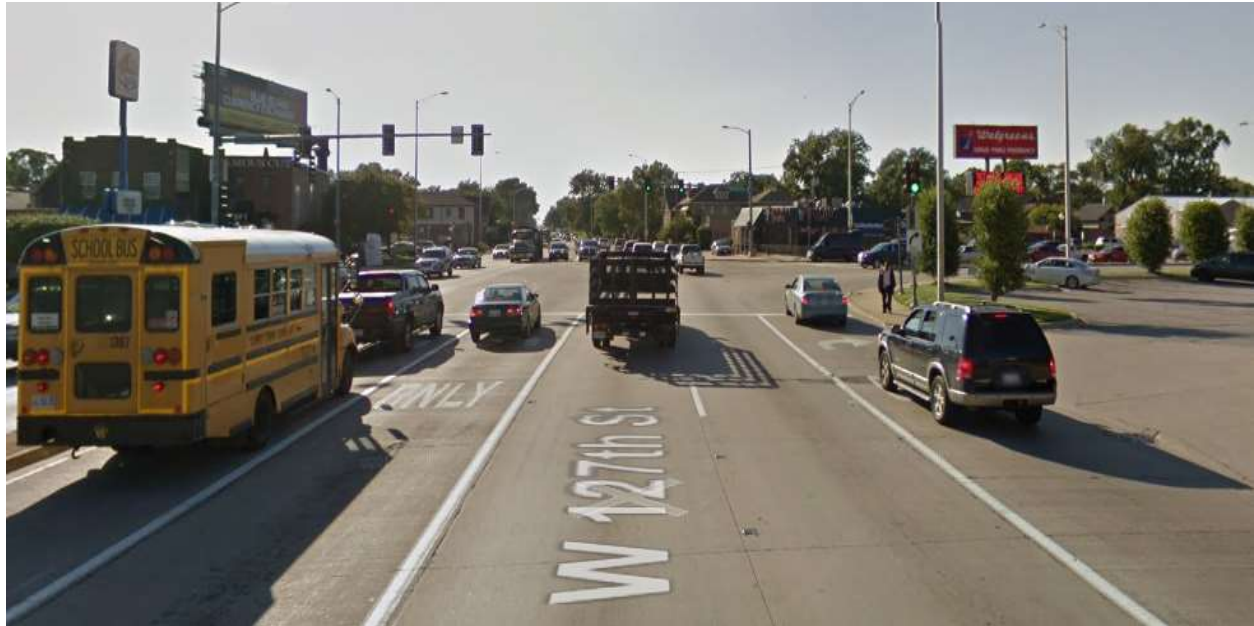
127th Street at Western Avenue, Westbound Approach
